ACCESS AUDIT

CONDUCTED IN 10 DISTRICTS OF ODISHA

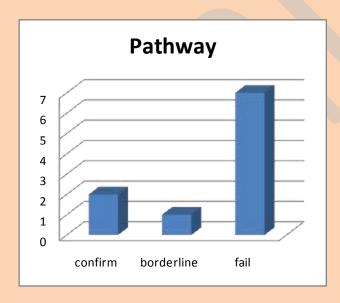
There are no general drainage systems in any of the places.

Dhen kanal	Jajpur	Khurda	Kalahandi	Kandhamal	Koraput	Ganjam	Nayagarh	Sambalpur	Mayurbhanj
1710mm	no	1200mm	no	no	no	no	no	2500mm	no

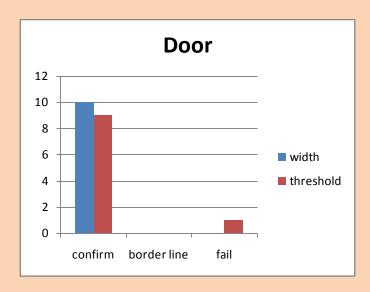
The door width in each district collector's office matches the standard size of the door entrance. No threshold was seen at the door entrance except Kalahandi which had a width higher than the standard norm. In some districts the door of the collector's cabin could not be opened single handedly because of the spring closers.

Dhenkanal	Jajpur	Khurda	Kalahandi	Kandhamal	Koraput	Ganjam	Nayagarh	Sambalpur	Mayurbhanj
1030 mm	1170 mm	1100mm	1070 mm	1370 mm	1550 mm	1030 mm	1050 mm	1200 mm	1500mm
no threshold	no threshold	no threshold	20 mm	no threshold	no threshold	no threshold	no threshold	no threshold	no threshold

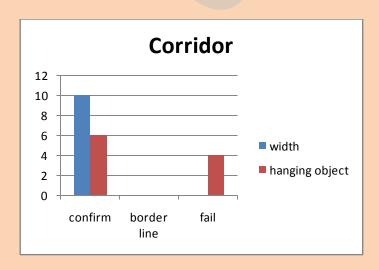
The standard width of the corridor was maintained in all the collector's office. In all the places it's more than the specified measurement. In half of the districts there was no hanging obstruction but in Khurdha, Kalahandi, Kandhamal and Mayurbhanj district hanging obstructions was found in form of notice board and other objects. Differences/gaps in corridor was bridged with ramp in Khurdha district and though there were objects i.e. chairs found in the corridor but sufficient space was there to move in between.

Dhenkanal	Jajpur	Khurda	Kalahandi	Kandhamal	Koraput	Ganjam	Nayagarh	Sambalpur	Mayurbhanj
3000	2400				2610	2700	2800	2700	
mm	mm	1800mm	2070mm	2540mm	mm	mm	mm	mm	3460mm
NA	NA	1500mm	1420mm	1350mm	NA	NA	NA	NA	1300mm

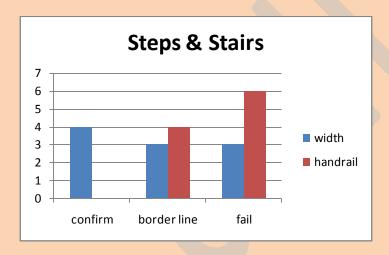
The width of the steps were not up to mark in case of Khurdha, Nayagarh and Kalahandi district collector's office having one side handrail in Khurdha, Kalahandi, Ganjam and Sambalpur districts. Districts like Dhenkanal, Jajpur, Kandhamal, Koraput, Nayagarh and Mayurbhanj did not have handrail. Existence of tactile tile was not observed in any of the steps/stairs and with no colour variation.

Dhenkanal	Jajpur	Khurda	Kalahandi	Kandhamal	Koraput	Ganjam	Nayagarh	Sambalpur	Mayurbhanj
1200 mm	3000mm	950m m	840m m	1200 mm	1200 mm	1400mm	840mm	1430mm	2000mm
no hand rail	no hand rail	one side hand rail	one side hand rail	no hand rail	no hand rail	one side handrail	no handrail	one side handrail	no handrail

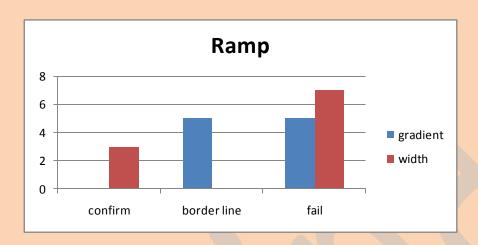
No ramp was found in Kalahandi, Kandhamal, Ganjam, Nayagarh and Sambalpur districts. Even though ramp was there in rest of the districts, the width of the ramp was not up to the mark in districts like Dhenkanal and Koraput. Ramps were made of tactile tiles but handrails were not attached in both sides of the ramp.

Dhenkanal	Jajpur	Khurda	Kalahandi	Kandhamal	Koraput	Ganjam	Nayagarh	Sambalpur	Mayurbhanj
-----------	--------	--------	-----------	-----------	---------	--------	----------	-----------	------------

1:03	1:06	1:07	no ram p	no ramp	1:02	no ramp	no ramp	no ramp	1:07
840 mm	1250 mm	1700 mm	NA	NA	950 mm	NA	NA	NA	1270 mm

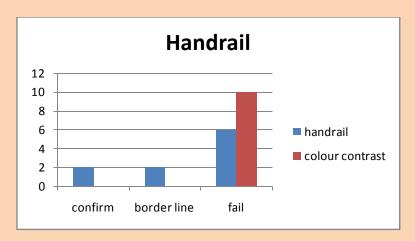
Both side handrail was found only in Dhenkanal and Koraput district collector's office, apart from that Khurdha and Ganjam offices had one side handrail and other did not have handrail. Contrast colour mark was not seen in any of the handrails.

Dhenkanal	Jajpur	Khurda	Kalahandi	Kandhamal	Koraput	Ganjam	Nayagarh	Sambalpur	Mayurbhanj
both side					both side	One side			
han drail	NA	one side	NA	NA	han drail	handr ail	NA	NA	NA
No	No	No	No	No	No	No	No	No	No
colo	colour	colou	colo	colou	colo	colour	colou	colou	colou
ur	contra	r	ur	r	ur	contra	r	r	r .
cont rast	st	contr ast	cont rast	contr ast	cont rast	st	contr ast	contr ast	contr ast

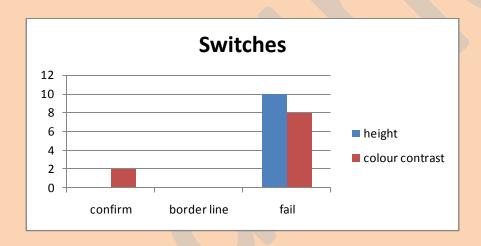
The switch and socket of the offices do not meet the standard height and are not accessible for the PWDs. No colour contrast is being maintained in many of the districts except Khurdha and Koraput.

Dhenkanal	Jajpur	Khurda	Kalahandi	Kandhamal	Koraput	Ganjam	Nayagarh	Sambalpur	Mayurbhanj
1450m m	1500 mm	1470 mm	1640 mm	1540 mm	1600 mm	1400 mm	1630 mm	1550mm	1420mm
no contrast colour	n no contr ast colou r	white & maro on	no contr ast colou r	no contr ast colou r	White & blue	no contr ast colou r	no contr ast colou r	no contrast colour	no contrast colour

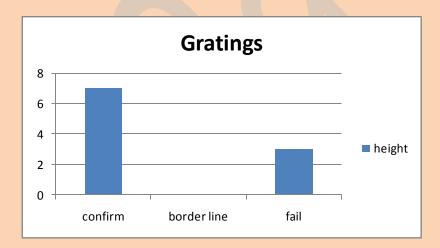
The District Social Welfare offices at Dhenkanal, Jajpur, Khurda, Ganjam, Kalahandi, Mayurbhanj and Koraput did not have any gratings. Whereas Kandhamal (80mm), Sambalpur(130mm) and Nayagarh (80mm) all failed the minimum grating gap specification. It was non-removable at all the existing places.

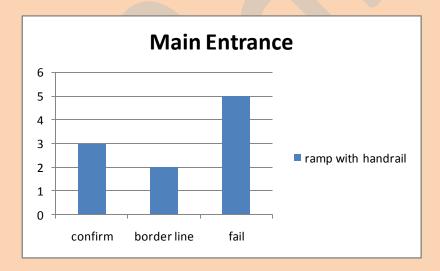
Dhenkanal	Jajpur	Khurda	Kalahandi	Kandhamal	Koraput	Ganjam	Nayagarh	Sambalpur	Mayurbhanj
Ram p with hand rail	Ram p with out hand rail	No ramp	No ramp	No ramp	Ramp with no handr ail	Ram p with hand rail	No ramp	Sam e level	No ramp

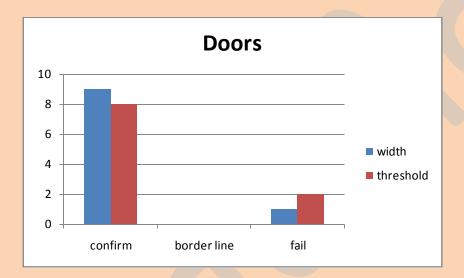
In all the districts except Ganjam the width of the entrance door of DSWO was wider than the minimum. A wheelchair can't go inside the DSWO's room because of the threshold existence in case of Kandhamal and Ganjam. Doormats can be put in front of the DSWO door entrance. Threshold can be removed from DSWO room and the door size can be widened in case found narrow.

Dhenkanal	Jajpur	Khurda	Kalahandi	Kandhamal	Koraput	Ganjam	Nayagarh	Sambalpur	Mayurbhanj
1040	1170	1100	1900	1020	1370	870m	1050	1200	1040
mm	mm	mm	mm	mm	mm	m	mm	mm	mm
No	No	No	No		No		No	No	No
thres	thres	thres	thres	100m	thresh	25m	thres	thres	thres
hold	hold	hold	hold	m	old	m	hold	hold	hold

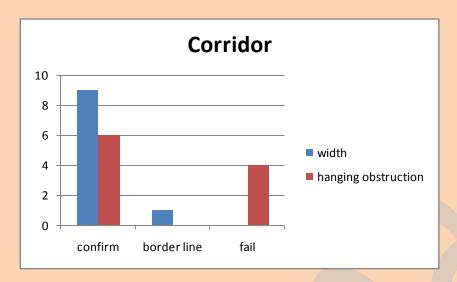
The width of the corridors of all the DSWO office is wider than the standard width and persons can easily move around. But some hanging objects were found there not more than the standard height, i.e. a notice board which may cause obstruction for many people in the districts of Dhenkanal, Mayurbhanj, Khurdha and Kandhamal.

1640		1500		1350			NA	NA	870m
mm	NA	mm	NA	mm	NA	NA			m

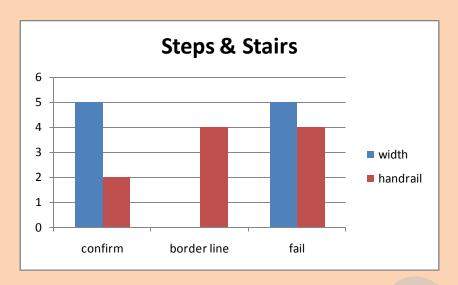
Except Jajpur, Mayurbhanj and Sambalpur district DSWO offices, the width of the steps were not up to mark in the other offices. Ganjam and Koraput do not have any steps/stairs. Districts like Khurdha, Nayagarh, Dhenkanal and Sambalpur offices have one side handrail and districts like Kandhamal, Kalahandi, Mayurbhanj and Jajpur did not have handrail. Tactile tile was not used in any of the steps/stairs. Colour contrast was not followed.

Dhenkanal	Jajpur	Khurda	Kalahandi	Kandhamal	Koraput	Ganjam	Nayagarh	Sambalpur	Mayurbhanj
1060 mm	3000 mm	950 mm	1020 mm	1100 mm	no stp/str	no stp/str	850 mm	1430 mm	2300 mm
one side	no handrail	one side	no handrail	no handrail	NA	NA	one side	one side	no handrail

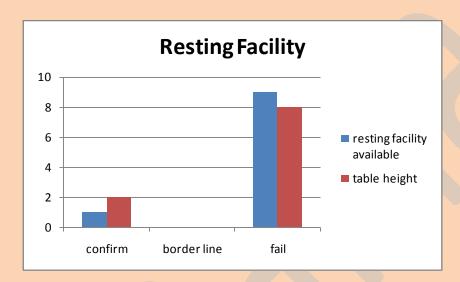
barring Ganjam and Kandhamal and the height of the table of these offices were in between the given measurement.

Dhenkanal	Jajpur	Khurda	Kalahandi	Kandhamal	Koraput	Ganjam	Nayagarh	Sambalpur	Mayurbhanj
NA	NA	NA	NA	One bench	NA	NA	NA	NA	NA
NA	NA	NA	NA	480 mm	NA	730 mm	NA	NA	NA

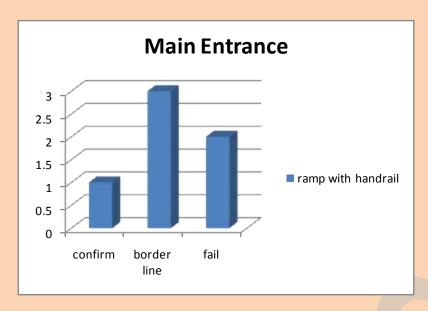
DDRC offices of Koraput, Kandhamal and Kalahandi had steps without handrails where as in Khurdha and Ganjam no step was found. Mayurbhanj office was closed during the audit. In Kalahandi, Khurdha and Ganjam district ramp exists but without handrail. There was no ramp in Kandhamal and Mayurbhanj district but ramp with handrail only exists in Koraput district.

Khurda	Kalahandi	Kandhamal	Koraput	Ganjam	M ayurbhan j
Ramp without handrail	Ramp without handrail	No ramp	Ramp with handrail	Ramp without handrail	No ramp

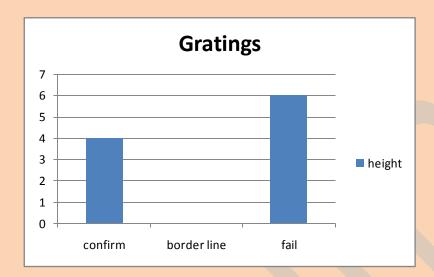
There were no gratings found in Khurdha, Ganjam, Jajpur and Nayagarh district. Whereas Koraput (36mm), Kalahandi (150mm), Kandhamal(70mm), Sambalpur(80mm), Mayurbhanj (70mm) and Dhenkanal (20mm) all failed the minimum grating gap specification. It was non-removable at all the existing places.

Dhenkanal	Jajpur	Khurda	Kalahandi	Kandhamal	Koraput	Ganjam	Nayagarh	Sambalpur	Mayurbhanj
20 mm	NA	NA	150 mm	70 mm	36 mm	NA	NA	80 mm	70 mm

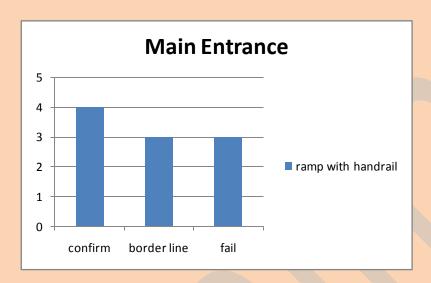
Ramps existed in districts of Ganjam, Koraput and Khurdha without handrail. No ramp was found in Dhenkanal, Jajpur, Kalahandi, Nayagarh and Sambalpur districts. Only in Kandhamal and Mayurbhanj districts there was ramp with handrails.

Dhenkanal	Jajpur	Khurda	Kalahandi	Kandhamal	Koraput	Ganjam	Nayagarh	Sambalpur	Mayurbhanj
no ramp	Same level	ramp without handrail	no ramp	ramp with hand rail	ramp without hand rail	ramp without handrail	no ramp	Same level	ramp with hand rail

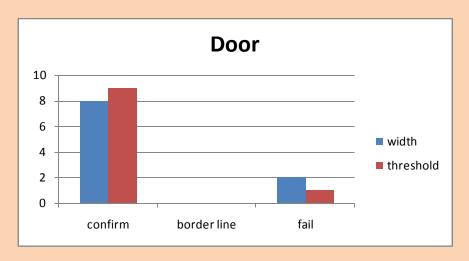
The width of the district hospital doors was accessible except Jajpur and Sambalpur district hospital. No threshold was found in many of the hospitals except Ganjam and Dhenkanal. But in Ganjam hospital the width (15mm) of the threshold was exceeding the standard norm where as in Dhenkanal it was (10mm) which is accessible. No doormat was found in any of the districts hospitals.

Dhenkanal	Jajpur	Khurda	Kalahandi	Kandhamal	Koraput	Ganjam	Nayagarh	Sambalpur	Mayurbhanj
980 mm	800 mm	1000mm	1050mm	1150mm	1370 mm	950 mm	1050 mm	820 mm	1280 mm
10 mm	no threshold	no threshold	no threshold	no threshold	no threshold	15 mm	no threshold	no threshold	no threshold

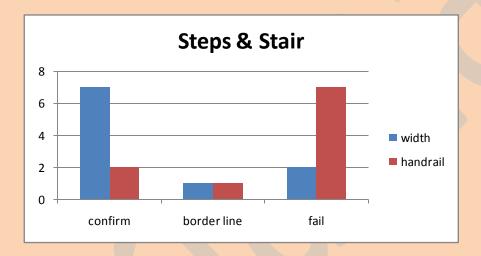
The width of steps/stairs of all the district hospitals were appropriate except Ganjam and Dhenkanal and both side handrails were attached in Ganjan and Khurdha districts and in Koraput one side handrail was present. There was no handrail in Dhenkanal, Jajpur, Kalahandi, Kandhamal, Nayagarh, Sambalpur and Mayurbhanj districts.

Dhenkanal	Jajpur	Khurda	Kalahandi	Kandhamal	Koraput	Ganjam	Nayagarh	Sambalpur	Mayurbhanj
900	2500		120	1400			2050	1650	1800
mm	mm	1850 mm	mm	mm	1320 mm	1050 mm	mm	mm	mm
NA	NA	both side	NA	NA	one side	both side	NA	NA	NA

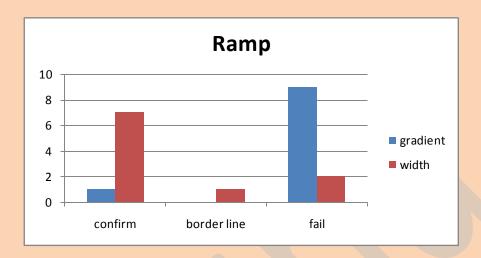
In all the districts except Dhenkanal, ramp was available in districts hospitals but none of the ramp gradient was matching the standard norm of 1:12. But ramp width of all the districts except Kalahandi and Jajpur was accurate where as in these 2 districts the ramps failed to match the standard width. Most of the ramps were made of tactile tiles.

NA	1:04	1:06	1:07	1:08	1:03	1:10	1:11	1:05	1:07
NA	1000	1500	720	1500	1200	1700	2250	1760	1540
	mm

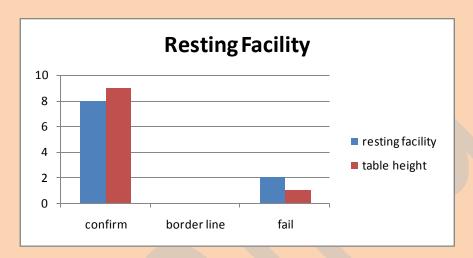
Resting facility was available in all of the district hospitals except Jajpur and Dhenkanal within the specified area. The height of the table was maintained in districts of Dhenkanal, Khurdha, Kalahandi, Kandhamal, Nayagarh, Sambalpur and Mayurbhanj but it failed in Koraput. But Ganjam and Jajpur districts hospitals had no tables.

Dhenkanal	Jajpur	Khurda	Kalahandi	Kandhamal	Koraput	Ganjam	Nayagarh	Sambalpur	Mayurbhanj
NA	NA	yes	yes	yes	yes	yes	yes	yes	yes
530 mm	NA	600 mm	460 mm	720 mm	1260 mm	NA	450 mm	450 mm	440 mm

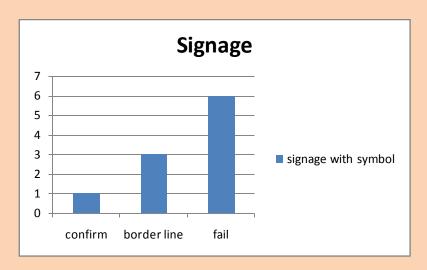
Signage: Few signages were marked in the district hospitals of Ganjam, Kalahandi, Kandhamal and Sambalpur but only in Ganjam international accessible symbols were present.

Dhenkanal	Jajpur	Khurda	Kalahandi	Kandhamal	Koraput	Ganjam	Nayagarh	Sambalpur	Mayurbhanj
NA	NA	NA	Signage without symbol	Signage without symbol	NA	Signage with symbol	NA	Signage without symbol	NA

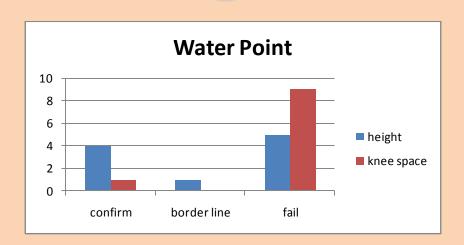
In the districts of Mayurbhanj, Sambalpur, Koraput and Kalahandi the water point was in an accessible height, while in Nayagarh, Ganjam, Kandhamal, Jajpur, Dhenkanal and Khurdha the water point was at a level higher than the standard height, hence not accessible.

Dhenkanal	Jajpur	Khurda	Kalahandi	Kandhamal	Koraput	Ganjam	Nayagarh	Sambalpur	Mayurbhanj
1030	1300	1000	410	1070	400	1200	1300 mm	920	950
mm	mm	mm	mm	mm	mm	mm		mm	mm
no	no	no	no	no	no	no	yes knee	no	no
knee	knee	knee	knee	knee	knee	knee	space	knee	knee
space	space	space	space	space	space	space	exists	space	space

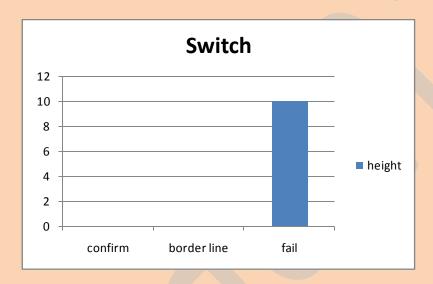
The height of the switches in all the district hospitals was more than the standard height and was not accessible. Also no colour contrast was maintained in the concern districts and in some districts the combination of the switch board was white & cream or white & yellow.

Dhenkanal	Jajpur	Khurda	Kalahandi	Kandhamal	Koraput	Ganjam	Nayagarh	Sambalpur	Mayurbhanj
1850	1400	1400	1580	1450	1370	1500	1380	1480	1570
mm	mm	mm	mm	mm	mm	mm	mm	mm	mm
