ACCESS AUDIT

CONDUCTED IN 10 DISTRICTS OF ODISHA

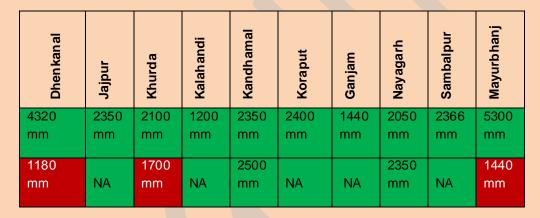
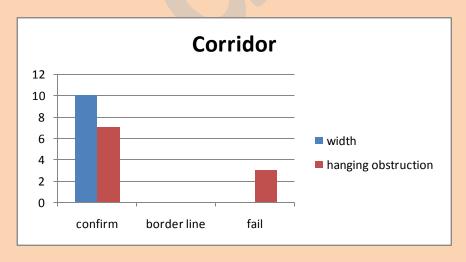
Steps & Stairs:

In all the districts hospitals there were wider corridors and hence accessible for all. No hanging objects found in Jajpur, Kalahandi, Koraput, Ganjam and Sambalpur districts. In Kandhamal and Nayagarh district hanging objects were placed higher than the standard norm and was not an obstruction. But in the districts of Mayurbhanj, Khurdha and Dhenkanal districts the hanging objects were not matching the specified height and yet obstructing.

The width of steps/stairs of all the district hospitals were appropriate except Ganjam and Dhenkanal and both side handrails were attached in Ganjan and Khurdha districts and in Koraput one side handrail was present. There was no handrail in Dhenkanal, Jajpur, Kalahandi, Kandhamal, Nayagarh, Sambalpur and Mayurbhanj districts.
